BASF Wyandotte

31<sup>st</sup> Street Landfill - Huntington

IW-5959-79

from Robert L. Jelacic

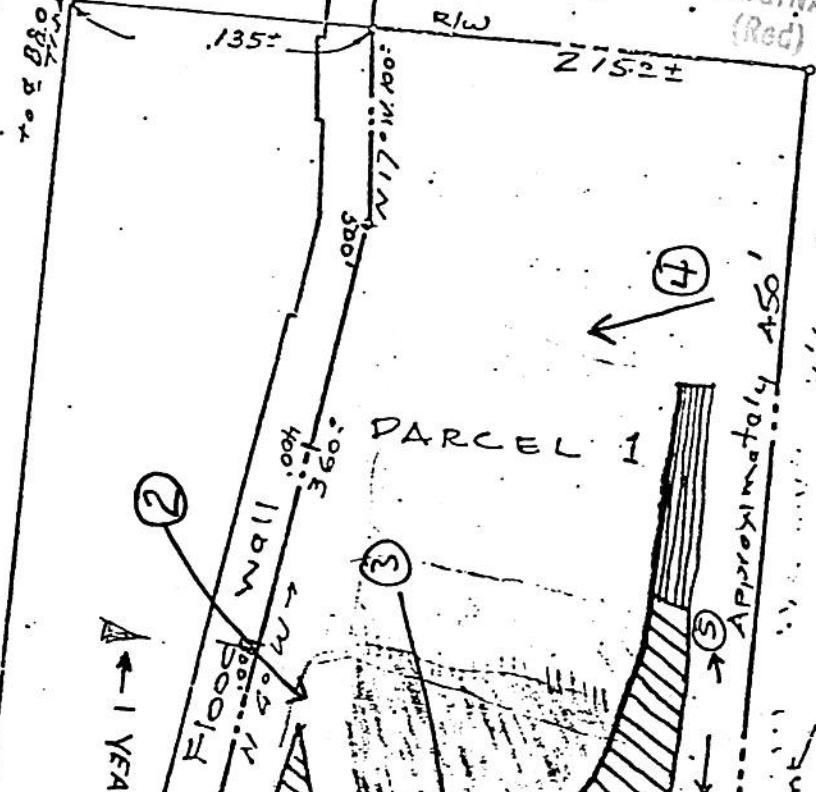
# LOC OF PIC

#1 - taken at the south end of the site ~ the oldest section - this shows evidence of runoff flowing south and indication of a white material probably the calcium sulfate (gypsum) waste material. - rivulets shown.

#2 The old section was covered with approximately one to two feet of ~~cover~~ topsoil ~ runoff noticeable coming off of the site. This picture shows the waste material dumped but not covered and a roadway leading up onto the site. - taken on west side of landfill.

#3 shows where new uncovered fill area starts. center of site

#4 North end of site where trees and shrubs were knocked over and covered ~ will have to be cleaned up before final cover is made. Also runoff and drainage evident in this area. Flow east to river which is approximately 50-60 ft from site.

#5 a picture of a partially uncovered ~~or~~ broken sack of the blue dye type material ~ more were evident
